MISSISSIPPI DEPARTMENT OF ENVIRONMENTAL QUALITY

Re: Inspection Report
US Navy, Naval Construction Battalion Center
Gulfport, Mississippi
Harrison County
GP-MS4 Coverage No. MSRMS4036

**Mississippi Department of Environmental Quality
Office of Pollution Control
Water Compliance Inspection Report**

Site Name: US Navy, Naval Construction Battalion Center

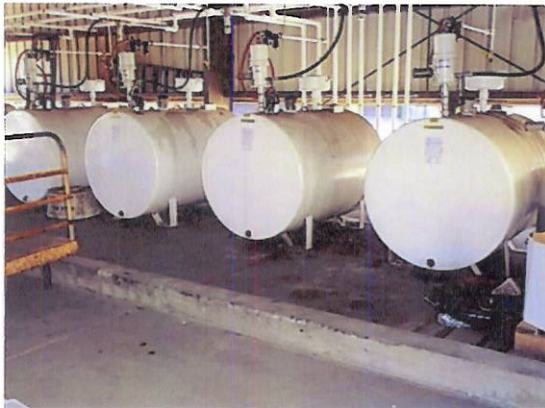
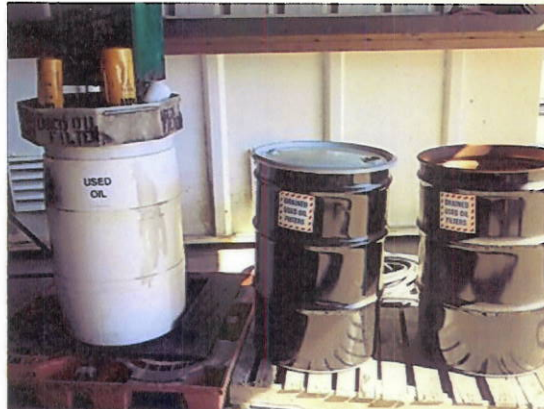
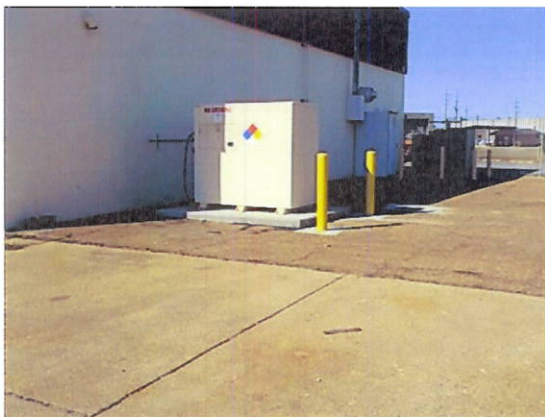
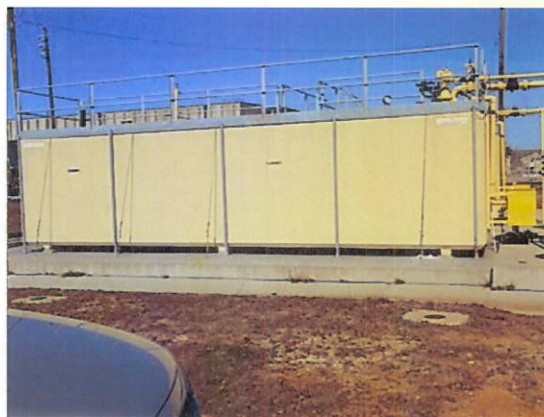
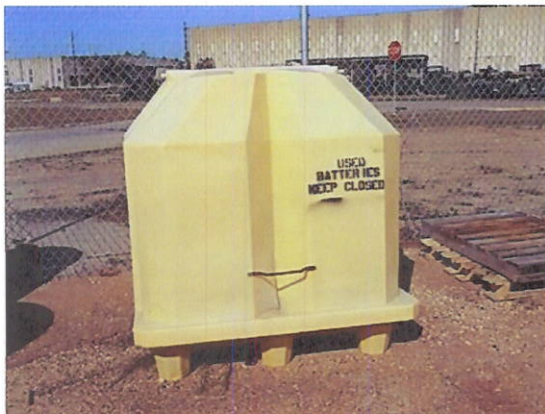
Examples of secondary containment used throughout sites on the Base

Diesel and fuel tanks are double-walled in addition to being placed in secondary containment. The base recently performed maintenance on the secondary containment areas, applying sealant to address cracks in the concrete structures.

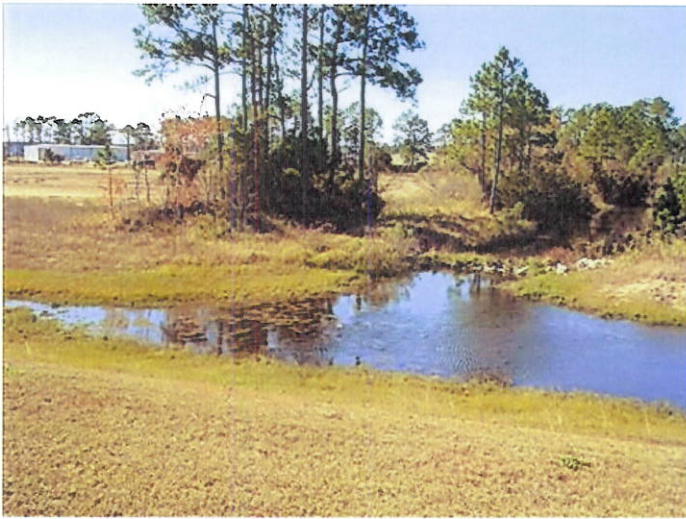
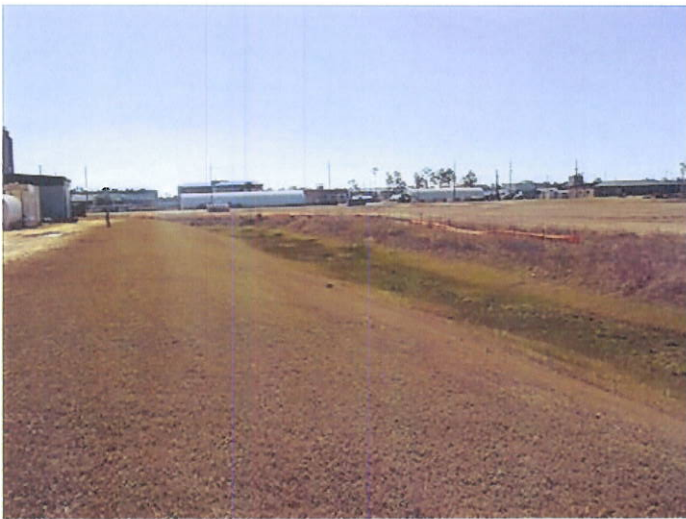
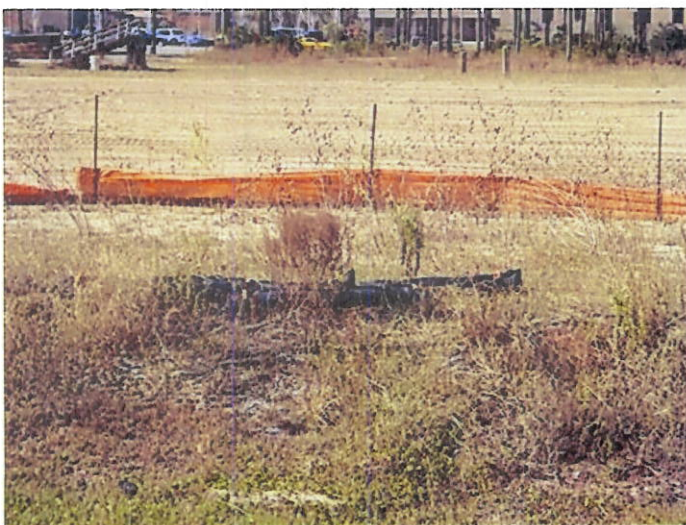
Erosion / Restoration Project at the Dozer Training Field

During the inspection, staff accompanied me to a training field for bulldozer operation. This field experienced heavy erosion along side a ditch from the operation of the heavy machinery. Orange silt fence was installed along the area to better alert operators of the eroded area. The area was recovered by placing mesh to promote vegetative growth. Signs were also posted along the area to make operators aware of the vulnerable area.

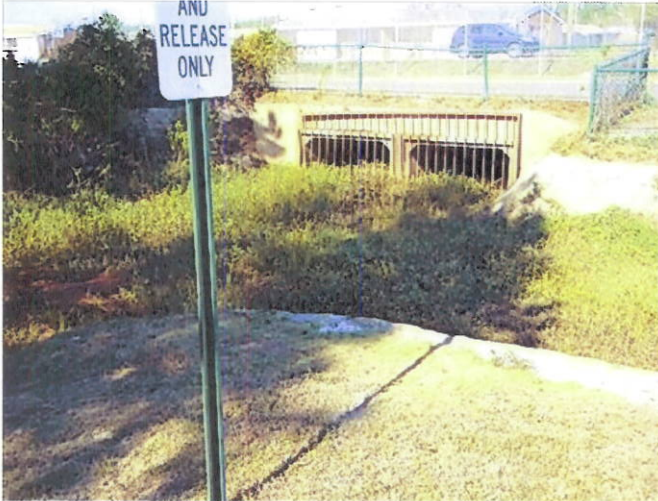
Outfall at Colby and 11th Streets

Next we inspected the north outfall (outfall #2) beside the dozer training field. There was a large vegetated buffer surrounding the outfall along with check dams in the contributing drainage ways. The next outfall inspected was at Colby and 11th street. The flowing water was clear and there were no signs of sedimentation or debris.

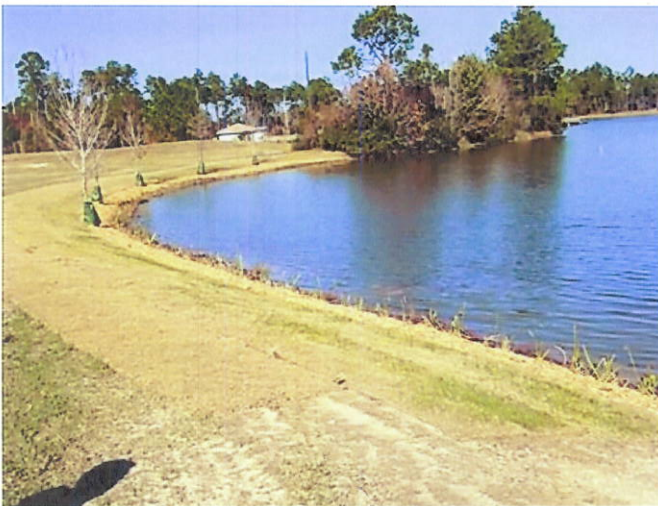
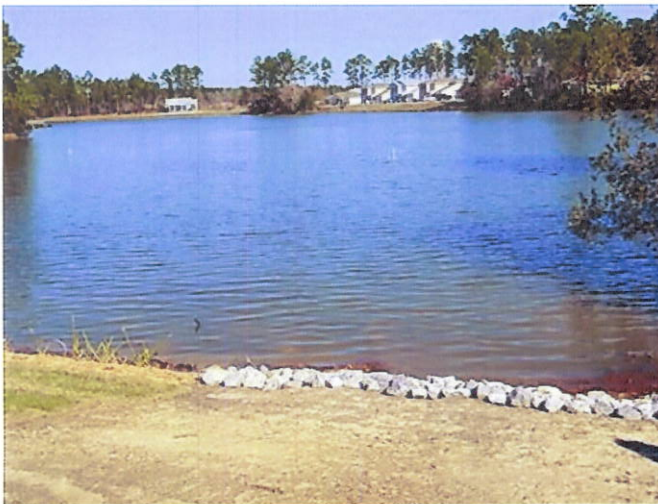
Seabee Lake Restoration Project

The Seebee Lake is located on the base's golf course. While this Lake was not designed to treat storm water runoff, it does receive a large load of runoff. In order to better protect the water quality of the Lake, the base has done extensive restoration of the Lake. Bank slopes were flattened in order to increase the littoral zone around the Lake. Cypress and red maple trees were planted along the perimeter of the Lake. Additional vegetation was also added to provide an additional layer of storm water filtration. Phase II of the restoration project is planned to be completed in 2012. Phase II will include an expansion of the Phase I project to other areas of the Lake's perimeter. The base also plans to add alum and aerators to help control the algae and keep the pH levels at water quality standards.

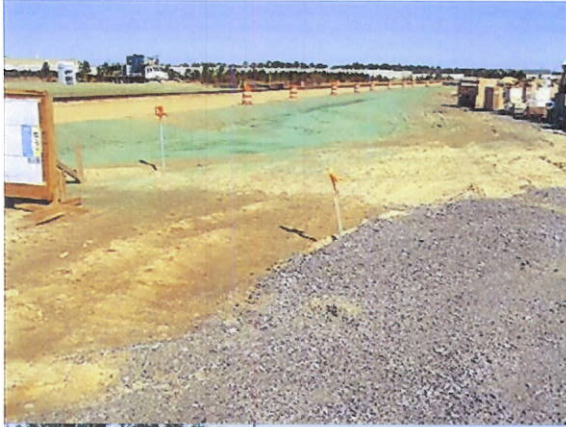
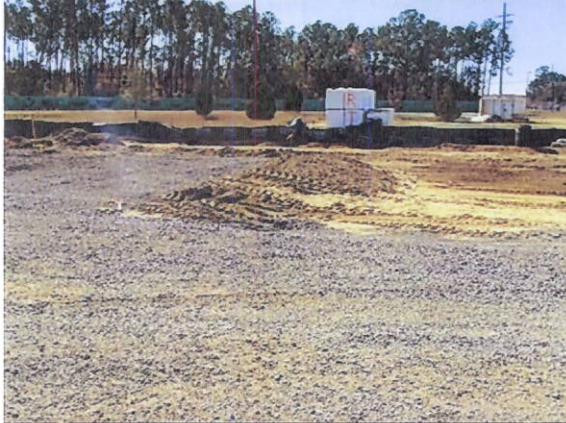
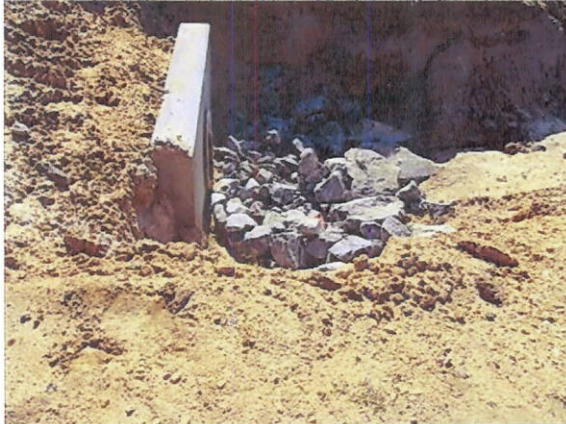
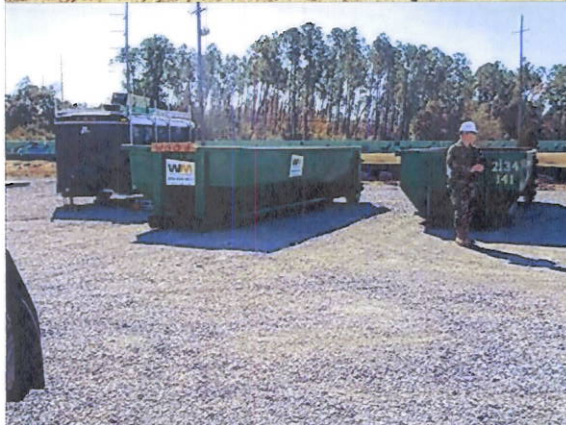
Proper Use of BMPs at the construction site of the Battalion Maintenance Facility project, including hydro-seeding for stabilization, use of coarse gravel, correctly installed silt fences, rip rap along channels, and recycle bins for construction materials. The site was in accordance with the SWPPP.

Our final inspection was performed at the Battalion Maintenance Facility project. The project is under the management of JJ Sosa Contractors. First a walk through of the site was done by both base personnel and representatives from JJ Sosa Contractors. It was apparent that there was a good working relationship between base personnel and the contractors. Several examples were shown where modifications in the original storm water pollution prevention plan had to be made due to insufficient erosion and sediment control measures. In addition to erosion and sediment controls, large dumpsters were on site to discard materials. There was a dumpster for concretes, metals, wood, cardboard, and plastics. Each dumpster was labeled and either recycled or disposed of properly.
